STATE OF CALIFORNIA
DEPARTMENT OF PUBLIC WORKS
DIVISION OF HIGHWAYS

MEDIAN BARRIERS
ONE YEAR'S EXPERIENCE
AND
FURTHER CONTROLLED FULL SCALE TESTS

Presented at the 41st. Annual Meeting of the
Highway Research Board, Washington, D.C.
January, 1962

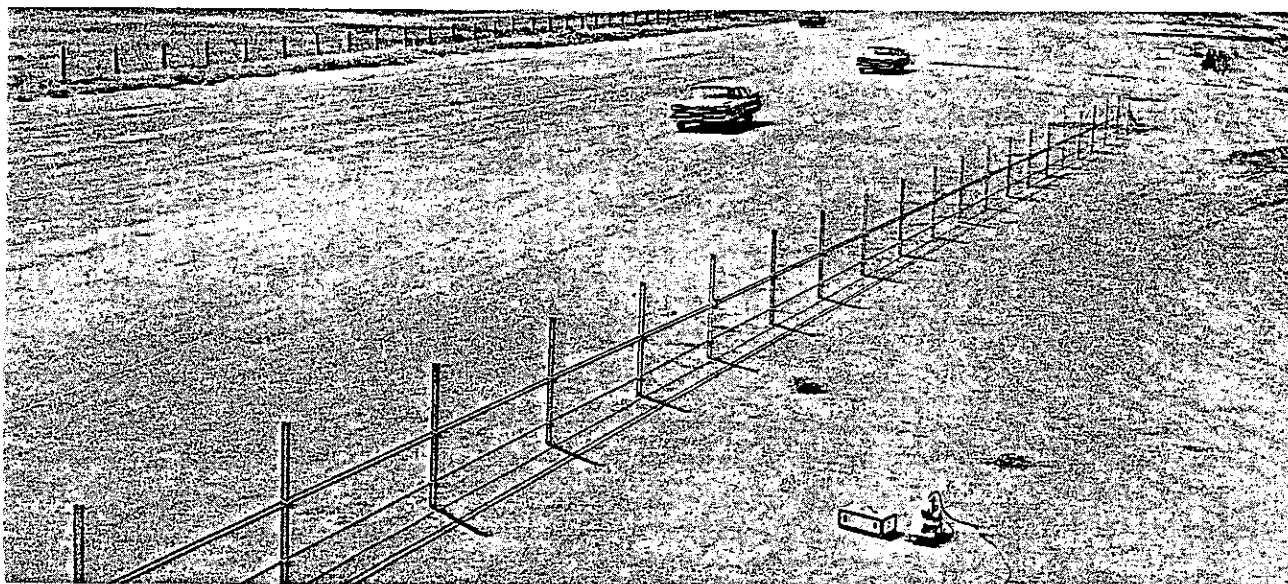
View of 7 degree collision course showing crash vehicle followed by control car. Chain link fabric was deleted from the first 200 ft. on the 600 ft. installations. Ground mounted data camera is in right foreground.

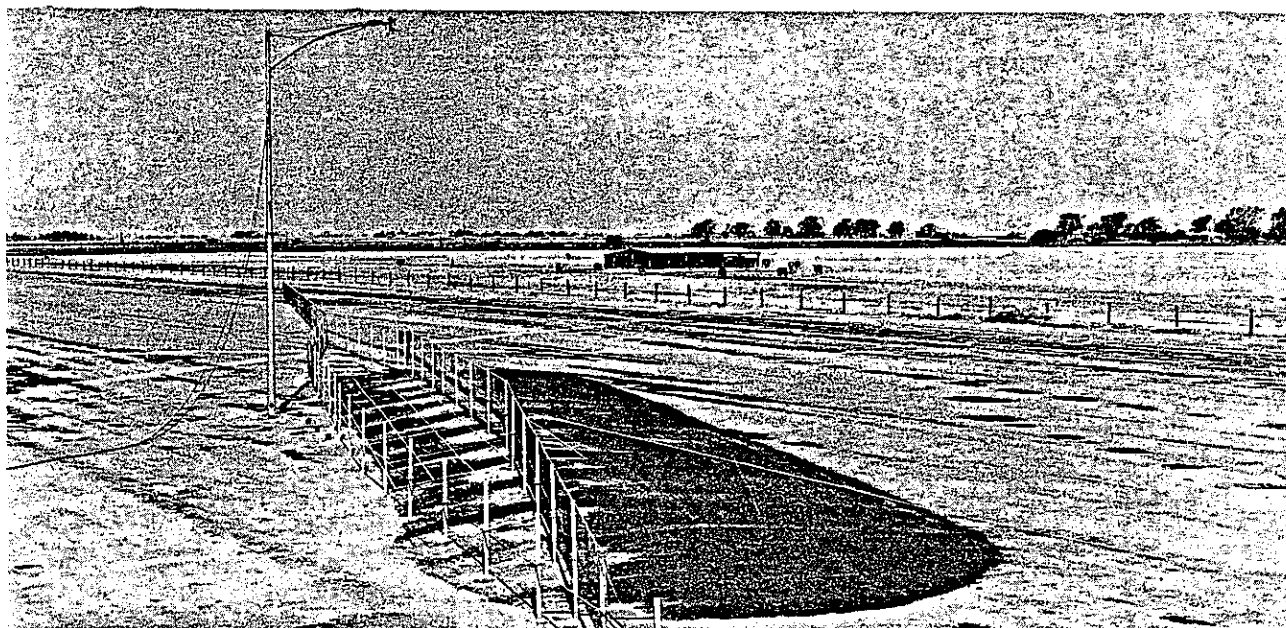
View of typical photographic instrumentation installation showing data camera tower, ground grid and guide tape intersecting point of impact at 20 degrees.
